## Success Story

Application: Ceramic Roof Tile Manufacturer

**Cost Savings: € 4 950**

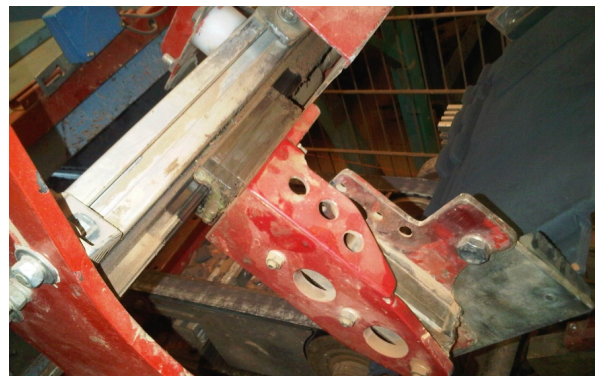
↑ Slide with solid lubrication K1 system

- Application review highlighted lubrication and sealing needed improving
- Introduced the solid lubrication system K1
- Improved sealing and protection
- Preload maintained longer due to reduced wear
- Reduced running friction resulting in reduced actuator pressure needed for same operation ( 6 to 4 bar)

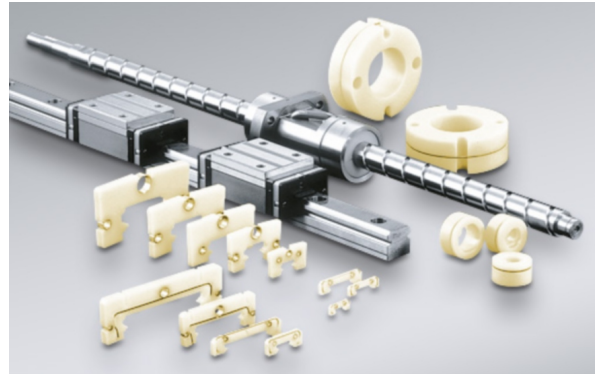
↑ Internal structure of K1 system

- Long-term, maintenance-free operation
- Available in accordance with the FDA
- Effective sealing function
- Applicable to all the linear guide models
- Regardless of the mounting orientation the operation of K1 units is always guaranteed
- Designed to operate in highly polluted environments
